ENGINEERING GEOLOGICAL INVESTIGATIONS  
OF THE  
WHARANUI EARTHFLOW  
NORTHEAST MARLBOROUGH

A thesis  
submitted in partial fulfillment  
of the requirements for the Degree  
of  
Master of Science in Engineering Geology  
in the  
University of Canterbury  
by  
L. JASON MORRIS

University of Canterbury  
1986

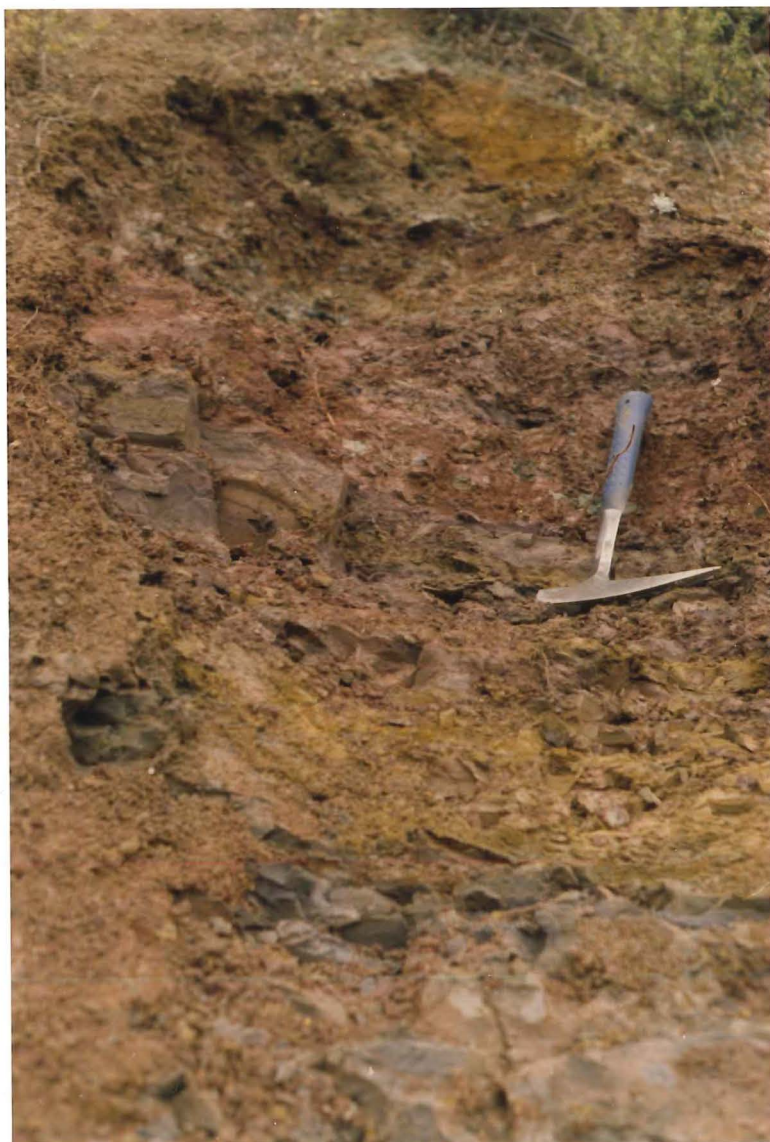
Figure 3.3 Red Mudstone - thin bed (30 - 40 cm) of red tuffaceous mudstone exposed in slump above Delta Stream. The Red Mudstone thickens to the west in Woodside Creek to 1.5 m and contains some volcanic breccia in other areas (S36 328E 426N).

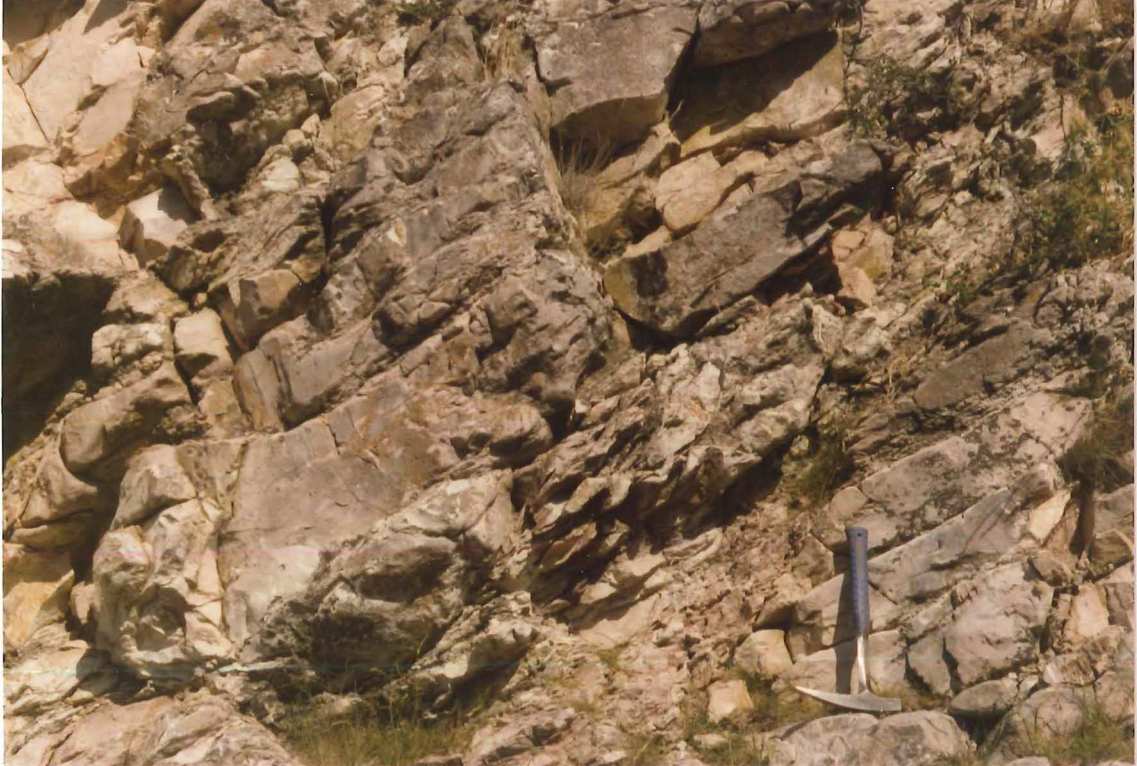
Figure 3.5 Shearing of Lower Limestone within the Woodside Fault zone. Shears are filled with greenish - grey gouge derived from interbedded mudstone (S36 320E 470N).

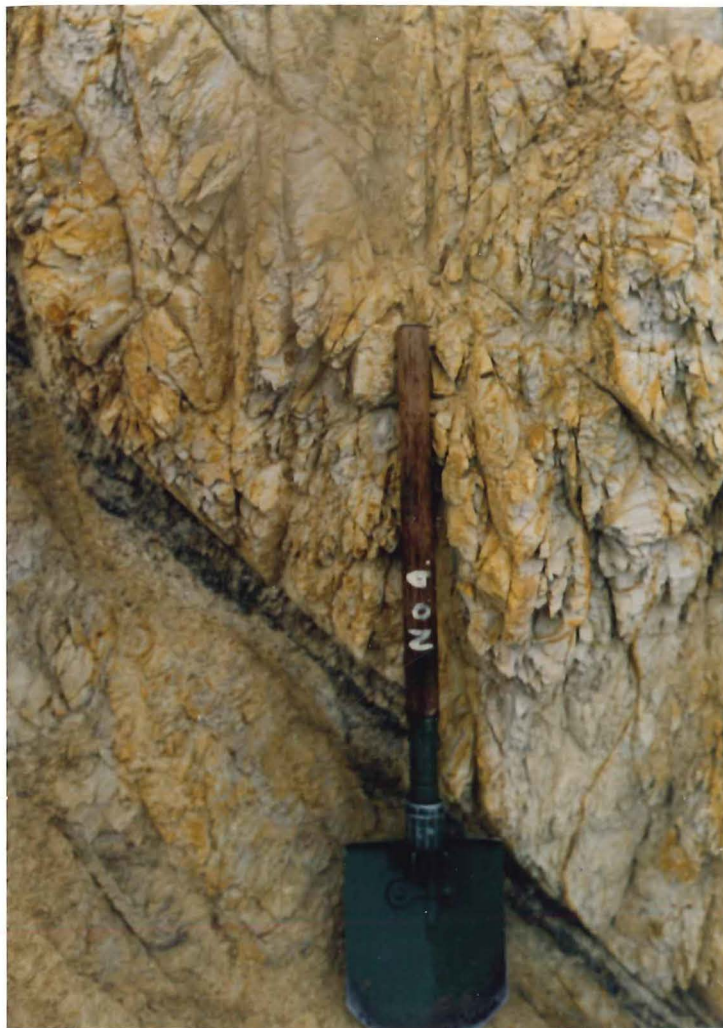
Figure 3.8  
Highly sheared Grey  
Argillites on south-  
western ridge above  
Wharanui Earthflow.  
Shovel is 60 cm  
long (S36 320E 460N).

The southwestern ridge is primarily composed of the Grey Argillites which have weathered to a buff colouring. This unit is marked by its intensely sheared nature (Fig. 3.8), and large siliceous concretions within the argillite (Fig. 3.9). These rocks are strong when fresh, but their highly sheared nature makes them susceptible to weathering, and failures within the weathered profiles are common (Fig. 3.10). Bedding attitudes are not distinguishable as they have been crushed and intensely sheared.

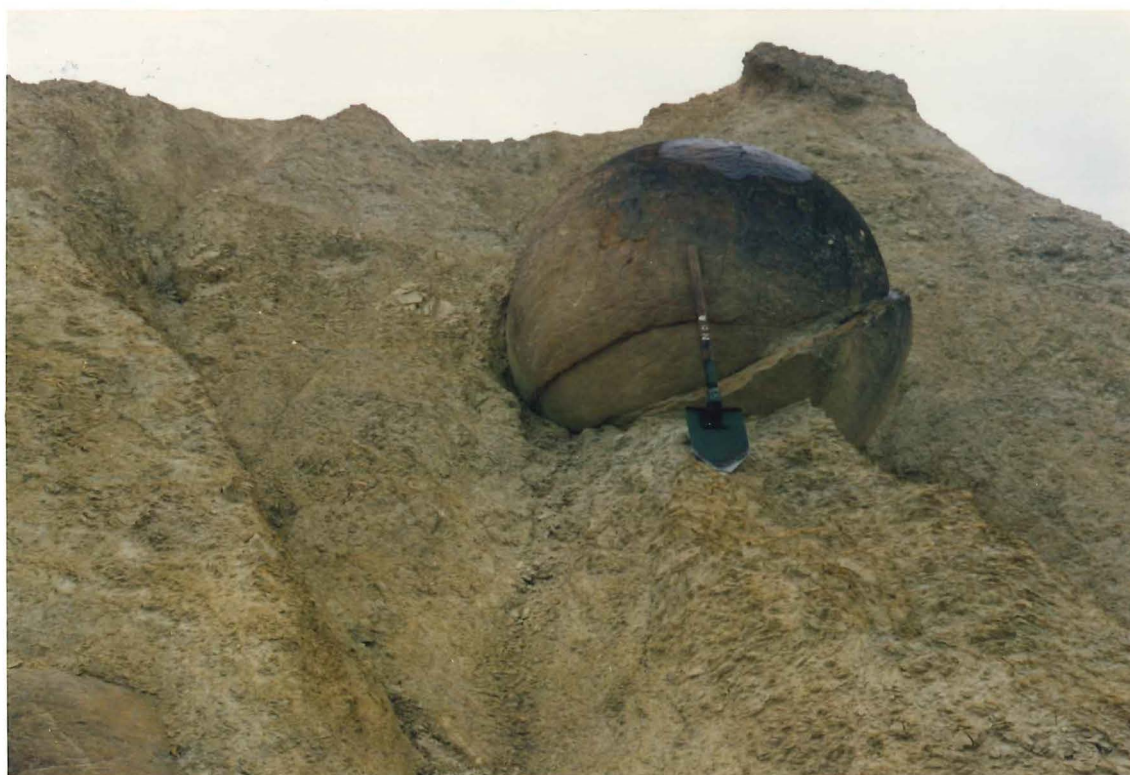
Figure 3.9 Large spherical concretions within the  
Grey Argillites (S36 457E 322N).

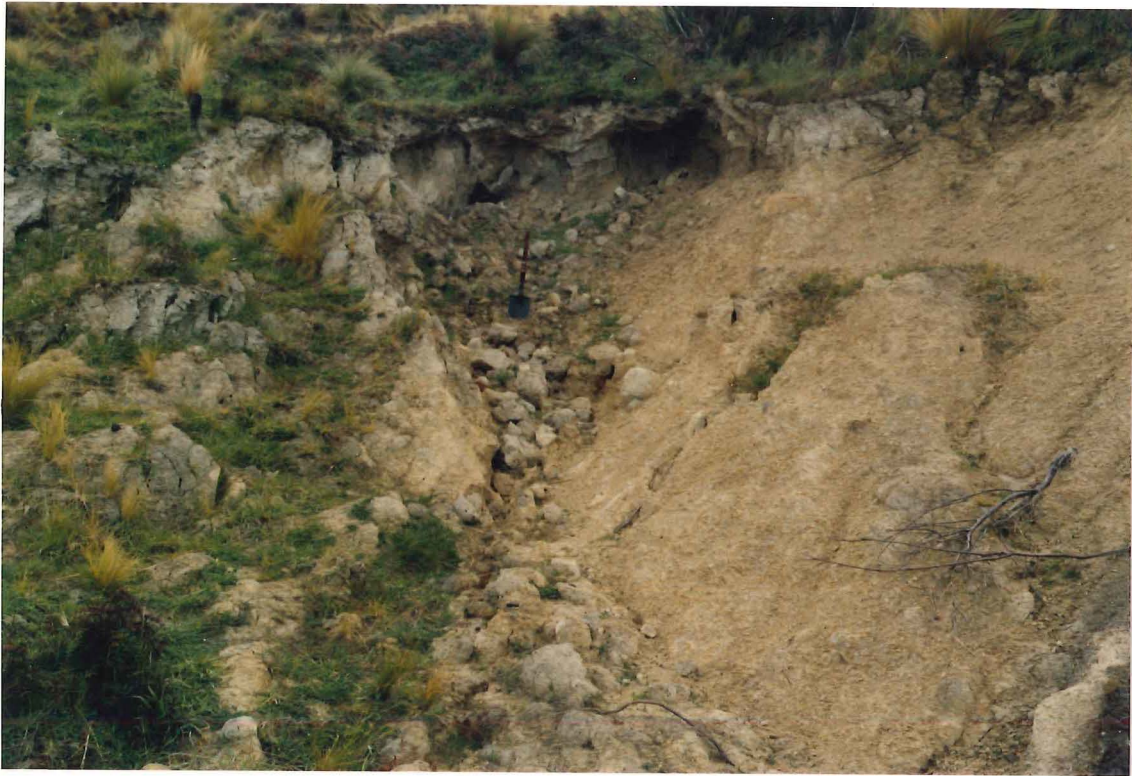
Figure 3.10 Earthslide within residual regolith, derived from highly sheared Grey Argillites at the base of the southwestern ridge. Failure occurred along the regolith - bedrock interface (8480E 7470N).

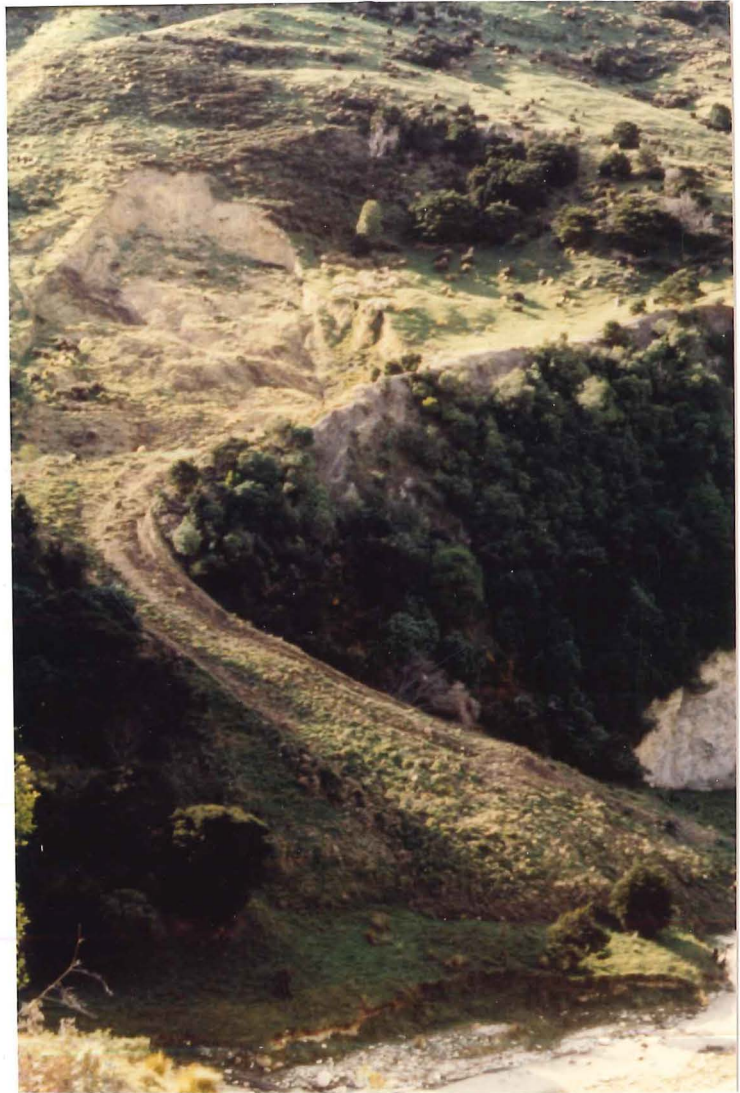
Figure 3.12 Active earthflow in southwestern sector, flowing into Woodside Creek within Woodside Fault zone. Note prominent headscarp and lateral ridges (S36 312E 403N).

The most active earthflow within the site occurs adjacent to the Woodside Fault and flows into Woodside Creek (Fig. 3.12). Recently it has been active and movement caused material to dam Woodside Creek for a short time (David Parsons pers. comm.) (Fig. 3.13). This earthflow shows many of the features described in Chapter Two. Relevant features include pronounced lateral shears, pressure ridges, ridges with slickensided surfaces, and a bulging toe which is tear-drop shaped. Due to the steep slope ( $22^{\circ}$ ), the very wet cohesive soils, and the continual removal of support by Woodside Creek, the earthflow appears to be continually active. During examination springs were noted in the headscarp, the material was very wet and could not support the authors weight. This earthflow has very similar material properties to the Wharanui earthflow. The major differences are in flow morphology and activity, which can be partially attributed to slope angle.

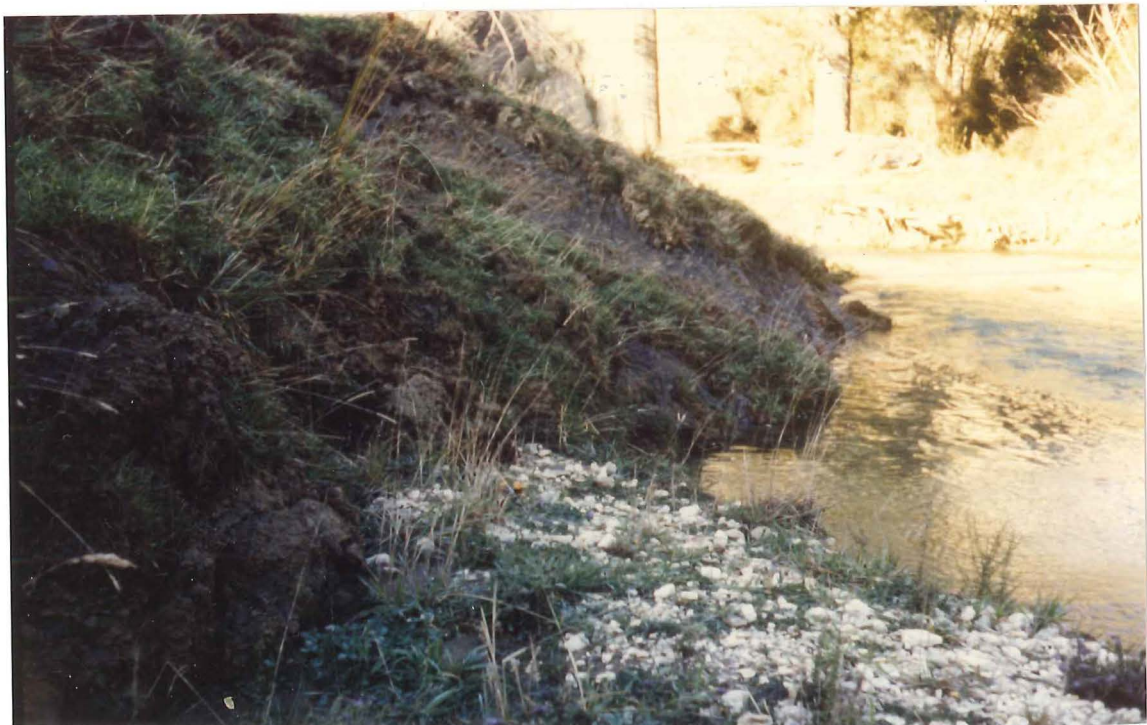
Figure 3.13 Toe of earthflow in 3.12 dammed Woodside Creek in June, 1985.

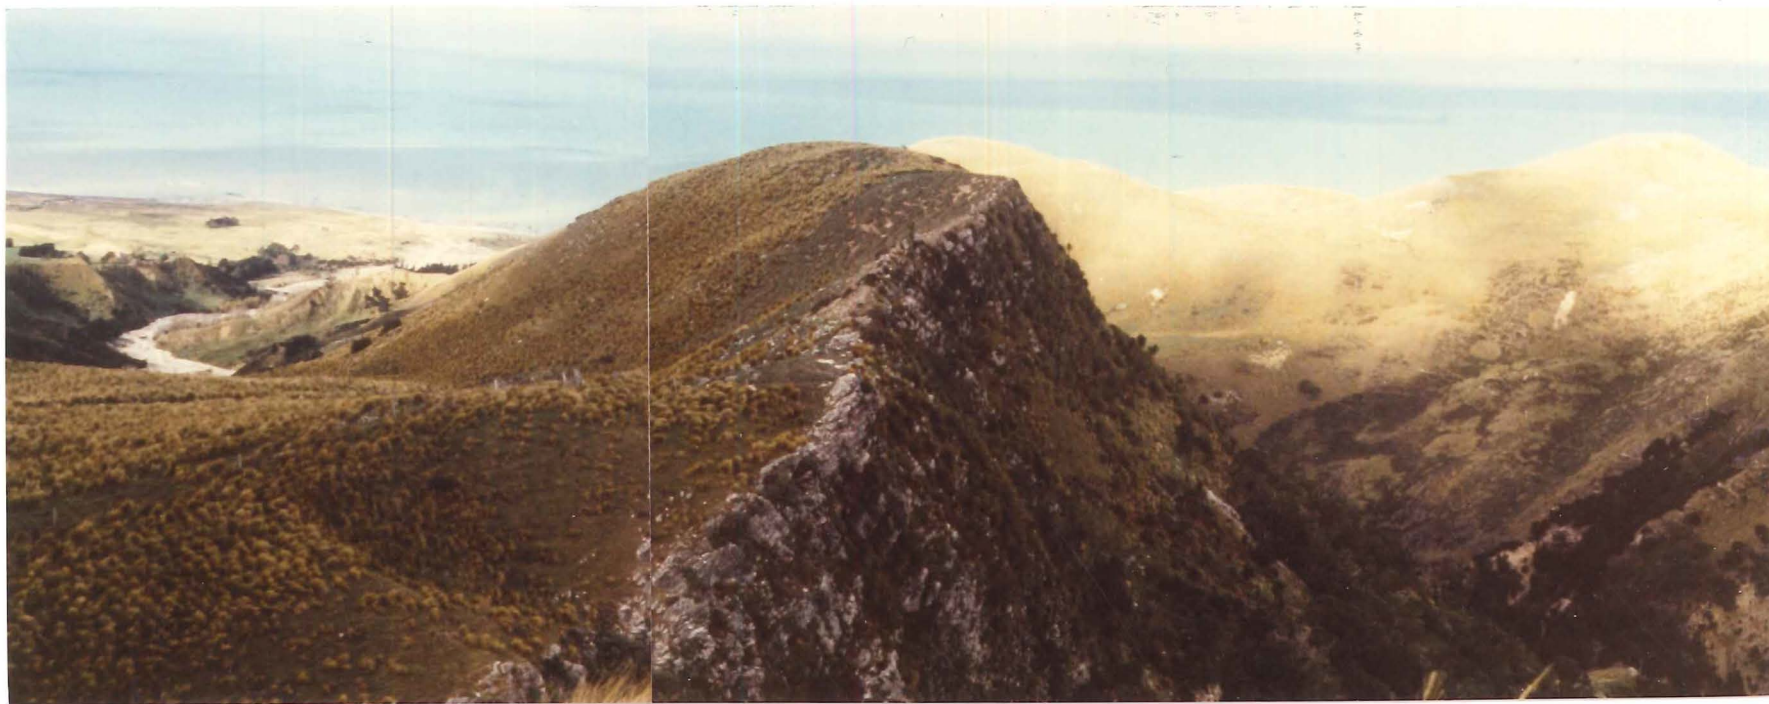
Figure 3.14 Limestone bluffs above the lower gorge of Woodside Creek, view looking east towards Wharanui Point (arrowed) S36 320E 480N.

This sector's most prominent feature is the lower gorge of Woodside Creek where bluffs are formed along the creek due to the competent, strong rocks of the Grey Argillites and Amuri limestone (Flint beds and Lower Limestone, Fig 3.14). This gorge is formed along the core of a steeply plunging anticline, and stress induced discontinuities along the core, (ie. joints and small faults) formed the path of least resistance so a drainage

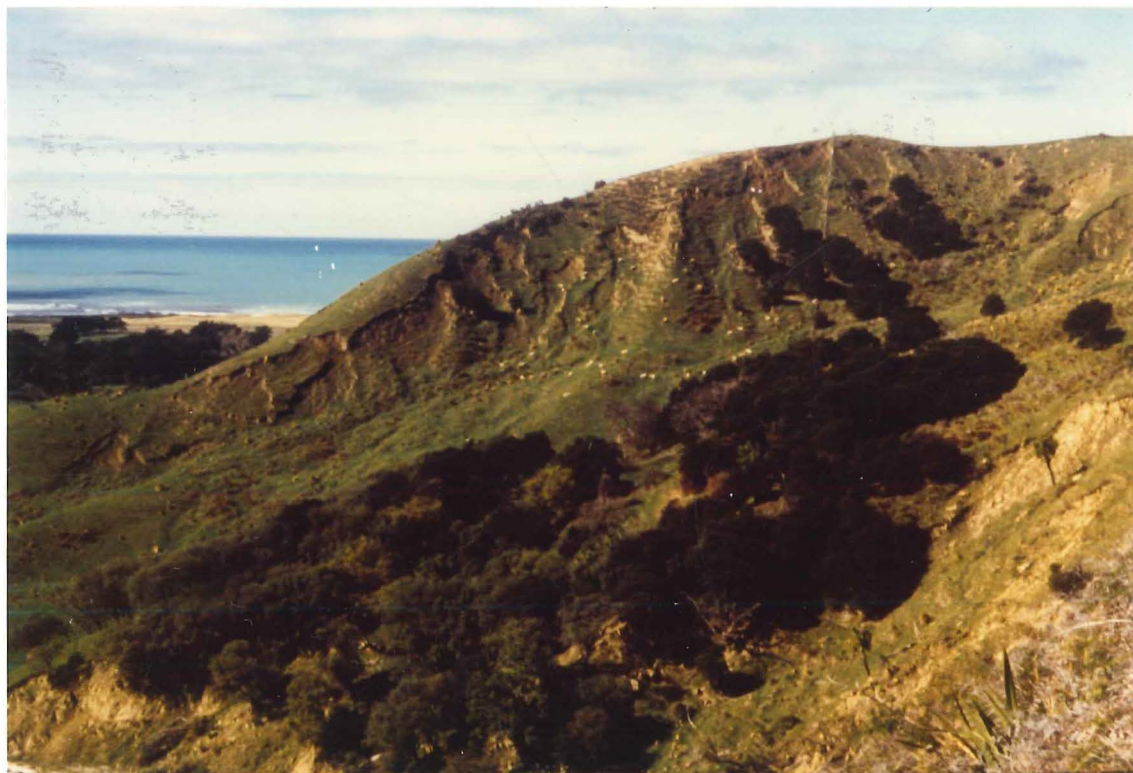
Figure 3.15 View looking east at south ridge above Woodside Creek (Wharanui Point is just outside top right corner of photo) S36 335E 478N.

The southern ridge is narrow and steep sided with numerous translational earth-slides occurring at the

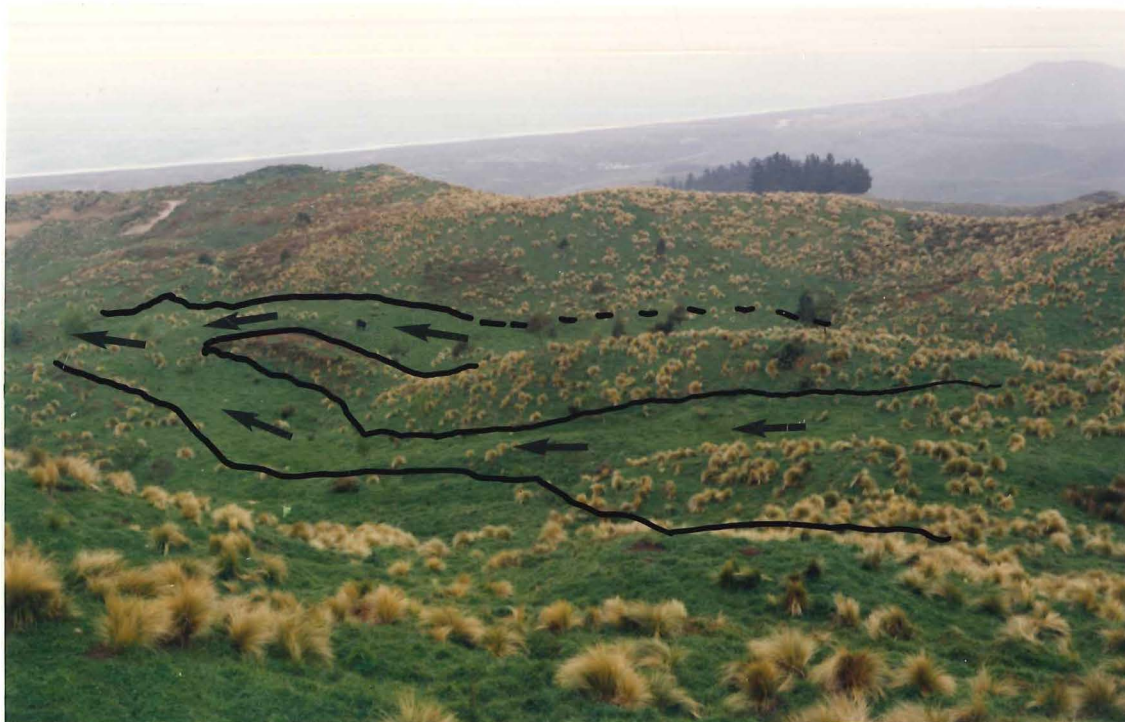
Figure 4.4 Stable ridge shown with coalescing earthflows (arrowed). Lines show outline of boundary shears. View is looking south from 8200E 7900N.

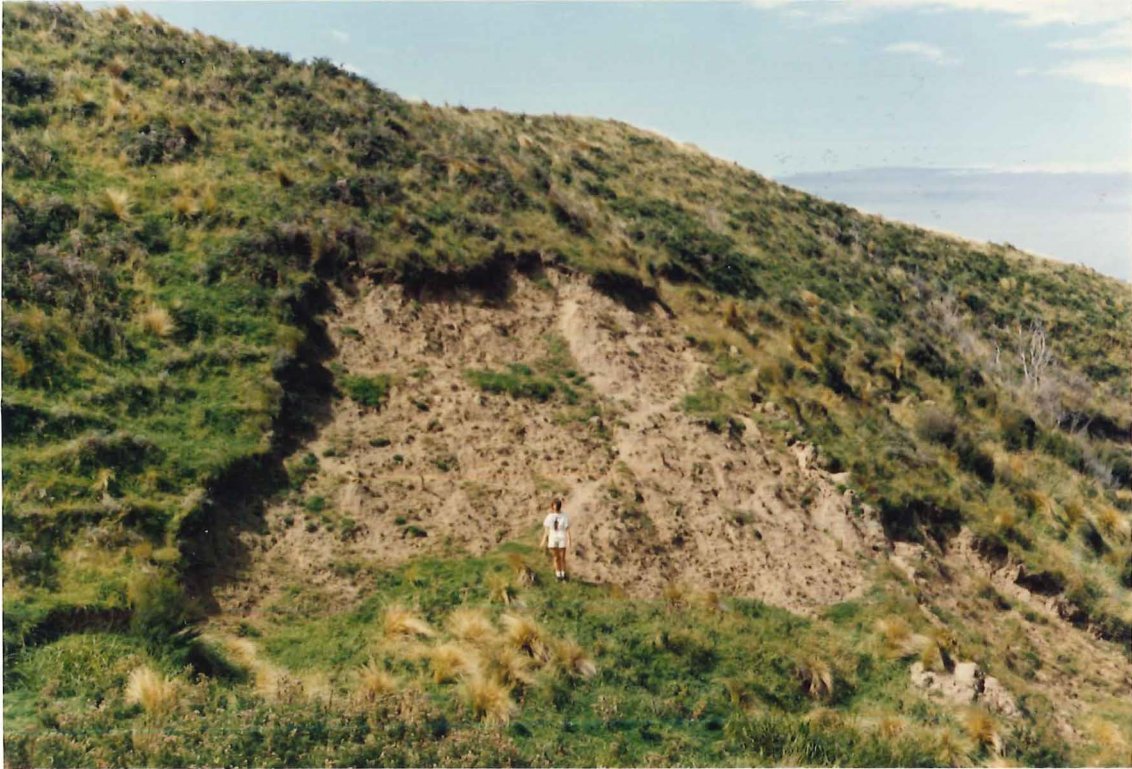
Figure 4.7 Shallow translational earthslide typical of those on the northeastern ridge above Wharanui Earthflow. View is looking northeast from 8500E 7600N.

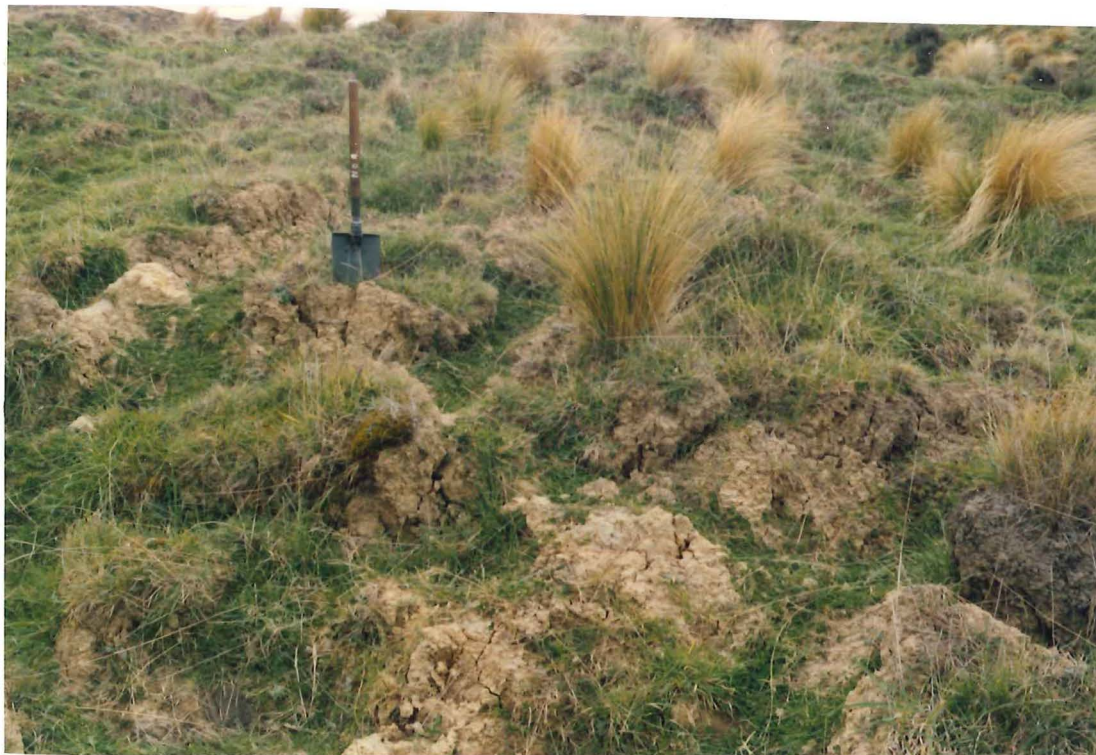
Figure 4.9 Hummocky broken ground surface typical of bulges within the Wharanui Earthflow. These turf mats are degrading as vegetation becomes established (8595E 7500N).

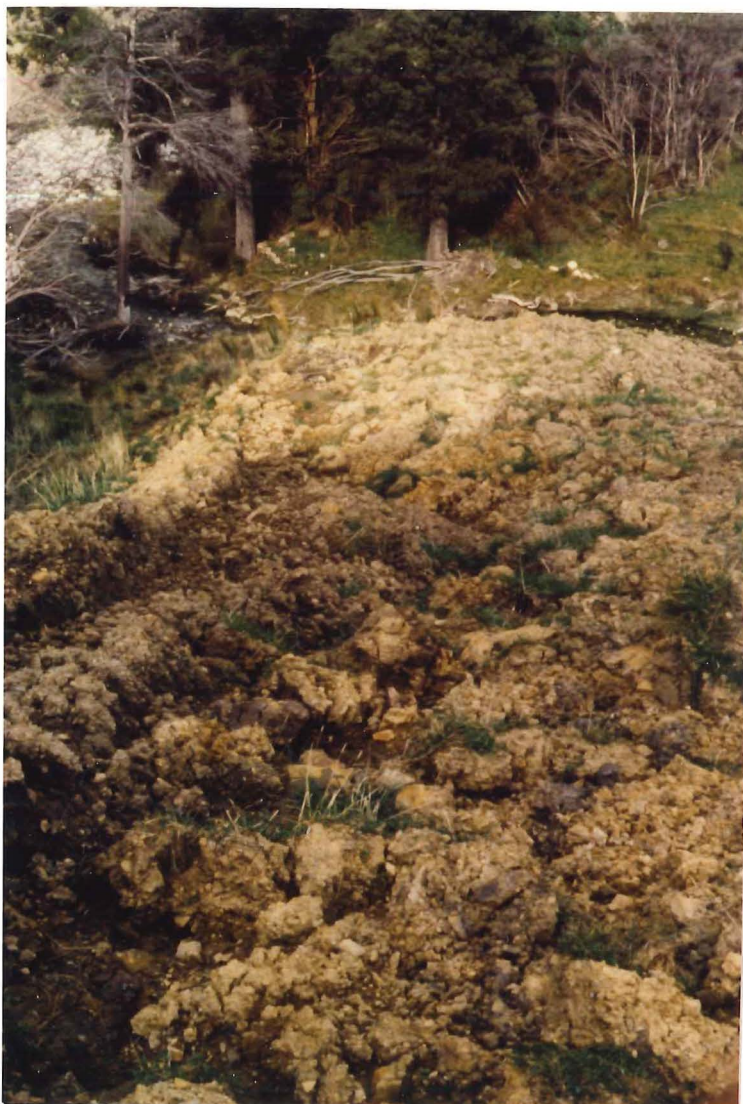
Figure 4.10 More recent lobe movement is demonstrated in another earthflow within the site. Note the lack of vegetation in contrast to Fig. 4.9 and the highly disrupted ground surface. View looking downslope where the earthflow toe occasionally blocks Woodside Creek (S36 312E 483N).

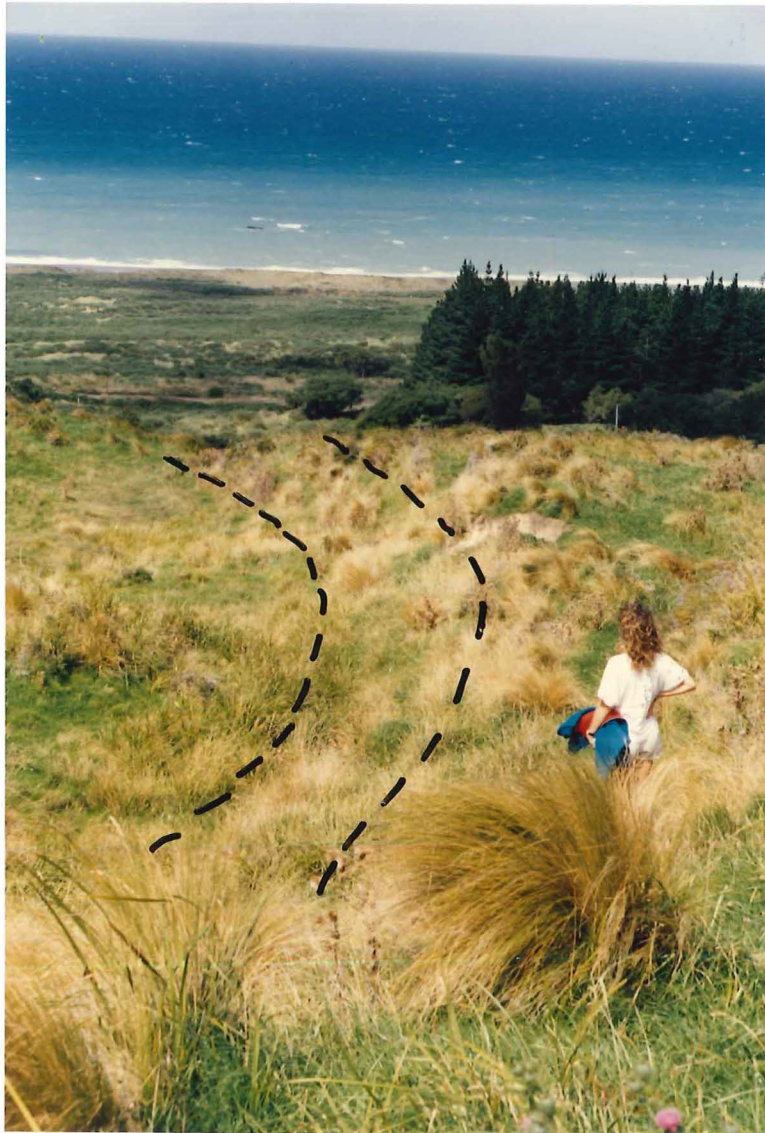
Figure 4.11 Degraded Lateral shear scarp (dashed outline) approximately 1.5 m high in the zone of accumulation. View looking south from 8550E 7490N.

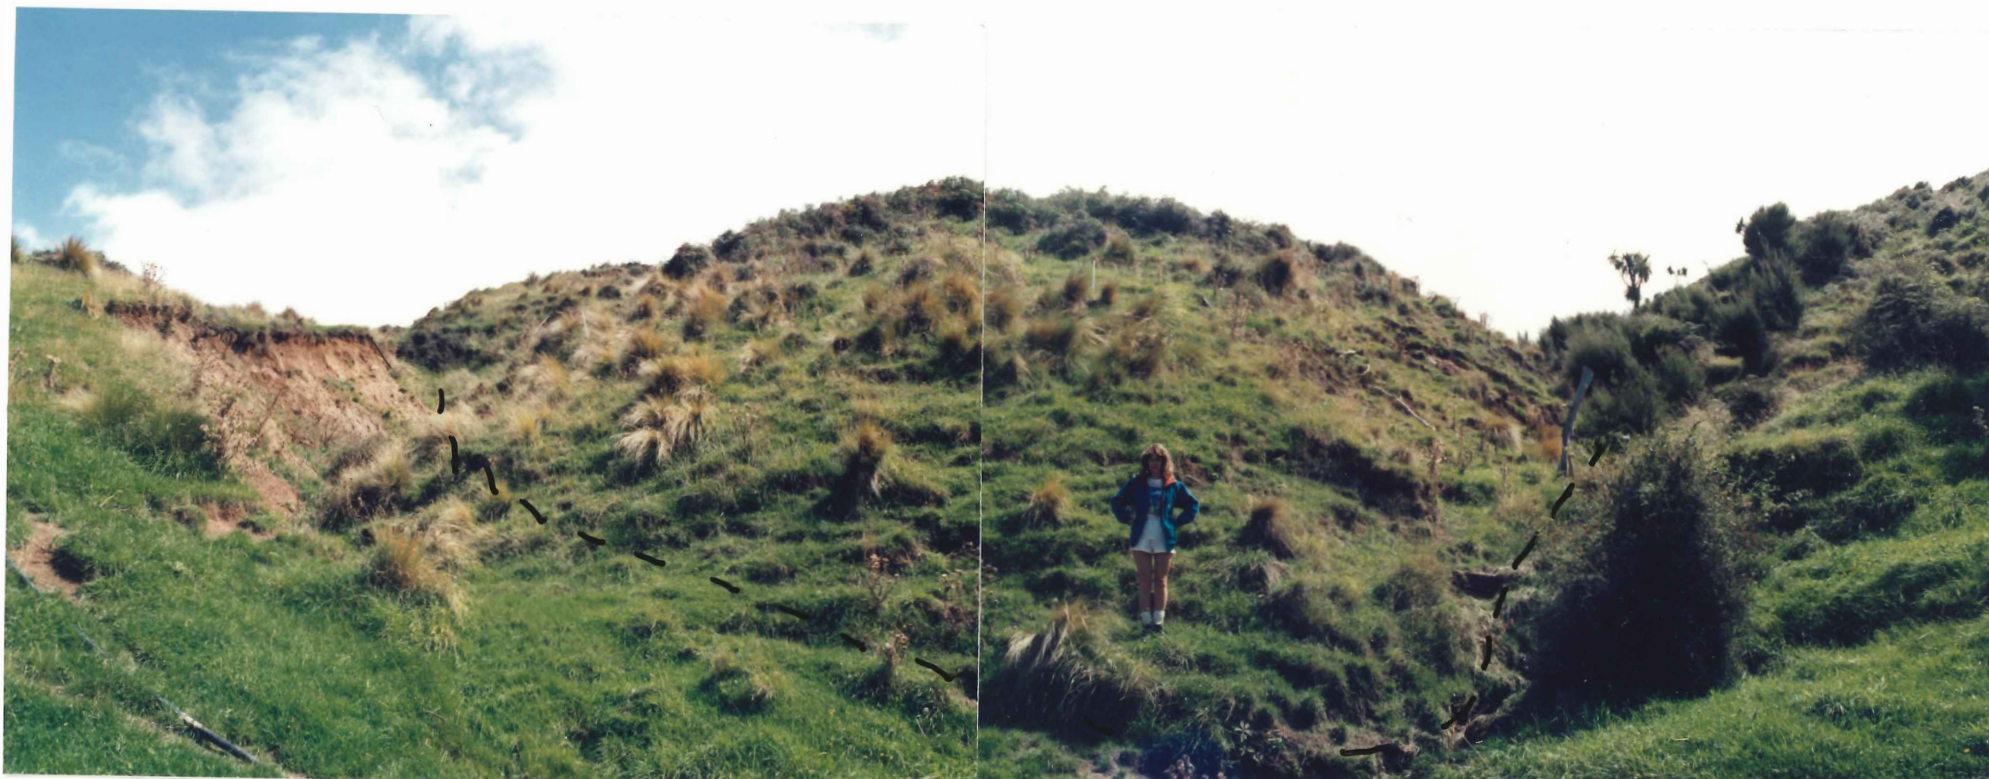
Figure 4.13 Terminal face of lobe five, with scarplets and active gully erosion on the flanks. View is looking northwest (upslope) from 8710E 7390N.

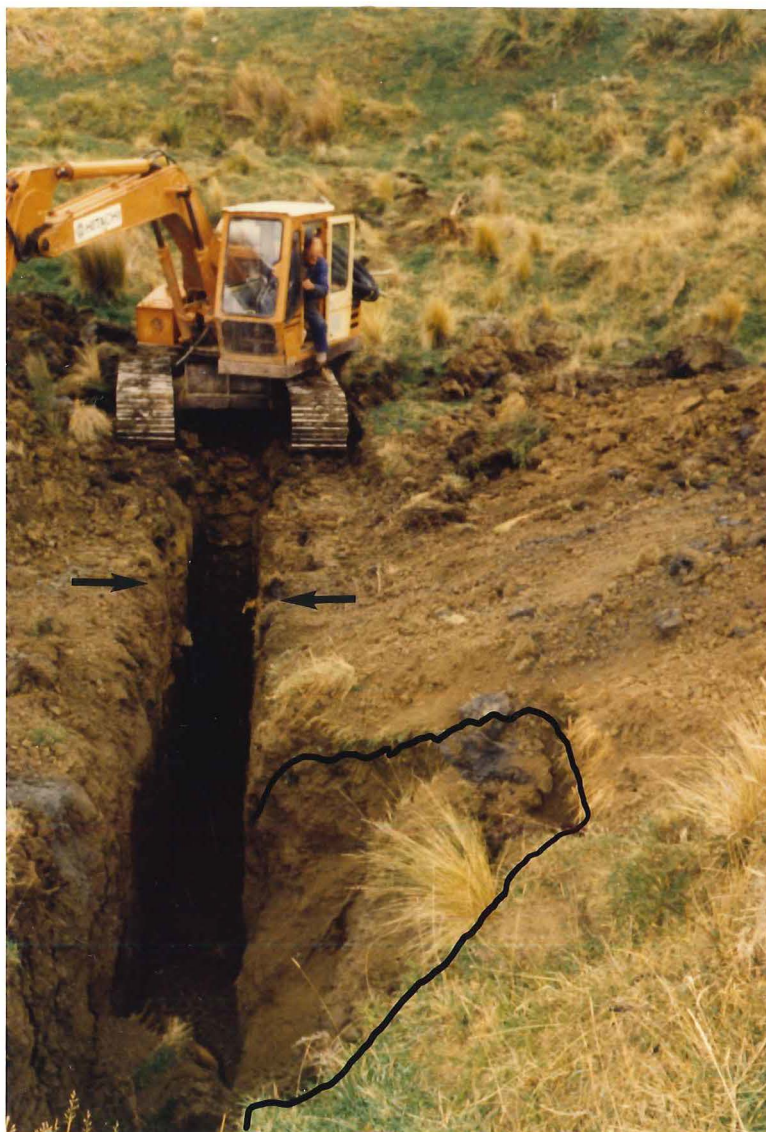
Figure 4.16 Excavation of Trench 1 showing collapse within sheared siltstone at northern end (lower part of photo) and bulging of walls at southern end (upper part of photo). The collapsing walls made entry into the trench impossible. Note water flowing into the trench (arrowed). (8600E 7505N).

Trench 1. Observations within the first trench were limited due to unsafe conditions at the time of excavation. The trench could not be entered to allow close examination, as there were sudden wall failures within the Grey Siltstone at the northern end of the trench, as well as bulging of trench walls at the southern end (Fig. 4.16).

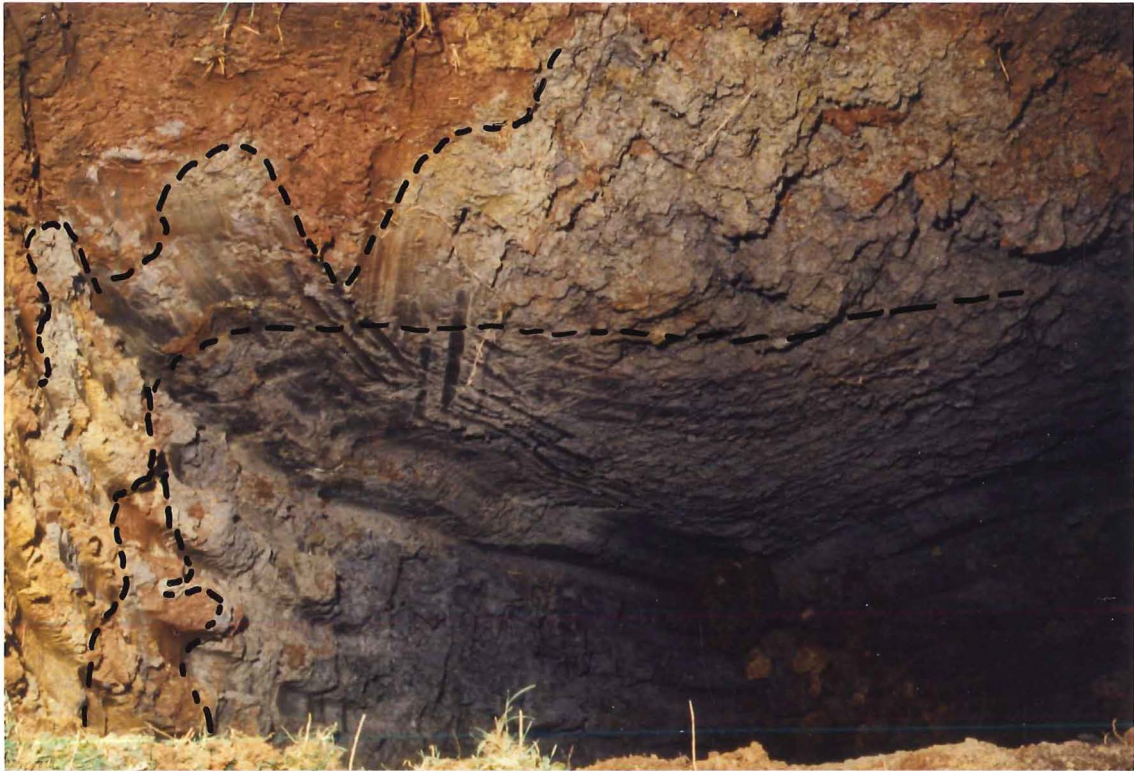
Figure 4.19 View looking down into Trench 2. Note irregular contact between red silty clay and yellowish brown clayey silt (dashed). Below the mixed colluvium the grey clayey silt is relatively homogeneous and apparently undisturbed. (8515E 7600N).

At approximately 1.4 metres depth within the trench a shear zone was noted. Below the shear zone the soil is a homogenous greenish-grey to bluish-grey clayey silt with some fine sand lenses (Fig. 4.18). Above the shear zone, colluvium is chaotically mixed, with highly irregular contacts between the colluvial soils (Fig. 4.19). Bedrock was not reached during excavation of this trench. The blue-grey clayey silts below the shear zone are thought to be in-situ soils as there were no shear surfaces located, nor was there any other evidence of movement such as mixing

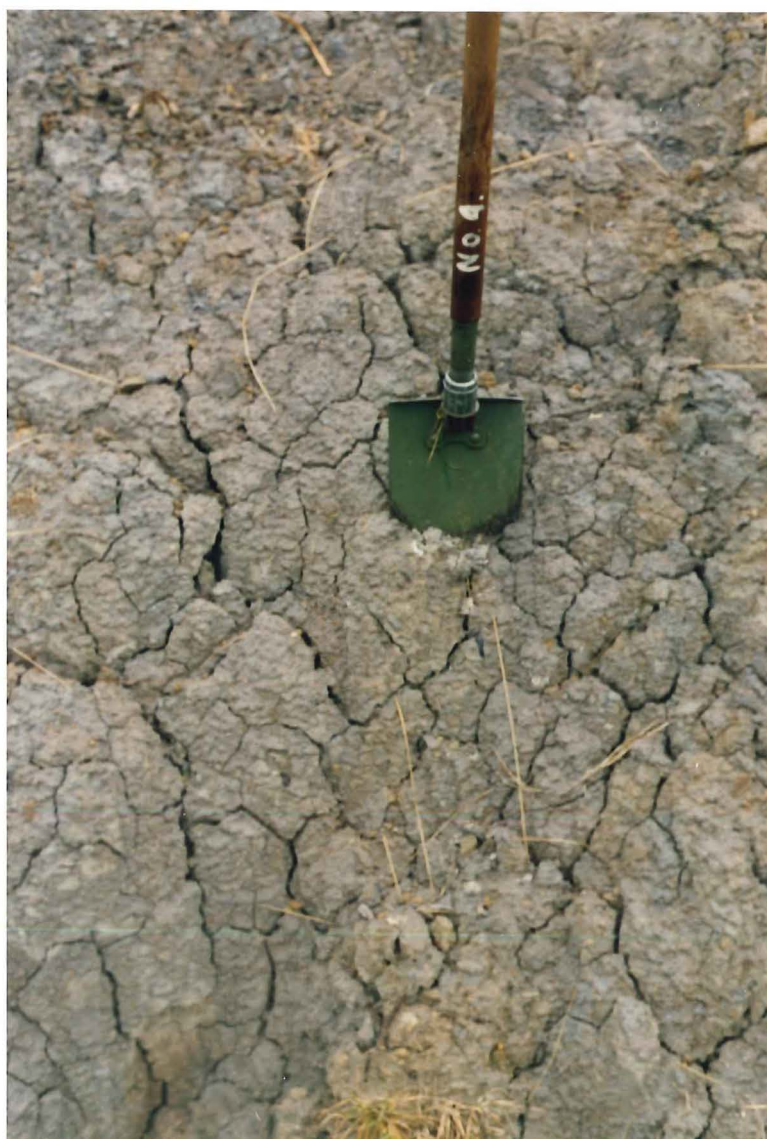
Figure 4.26 Shrinkage cracks formed within grey clayey silt colluvium. Exposure within gully on lateral margin of the earthflow. Spade is 60 cm long (8652E 7440N).

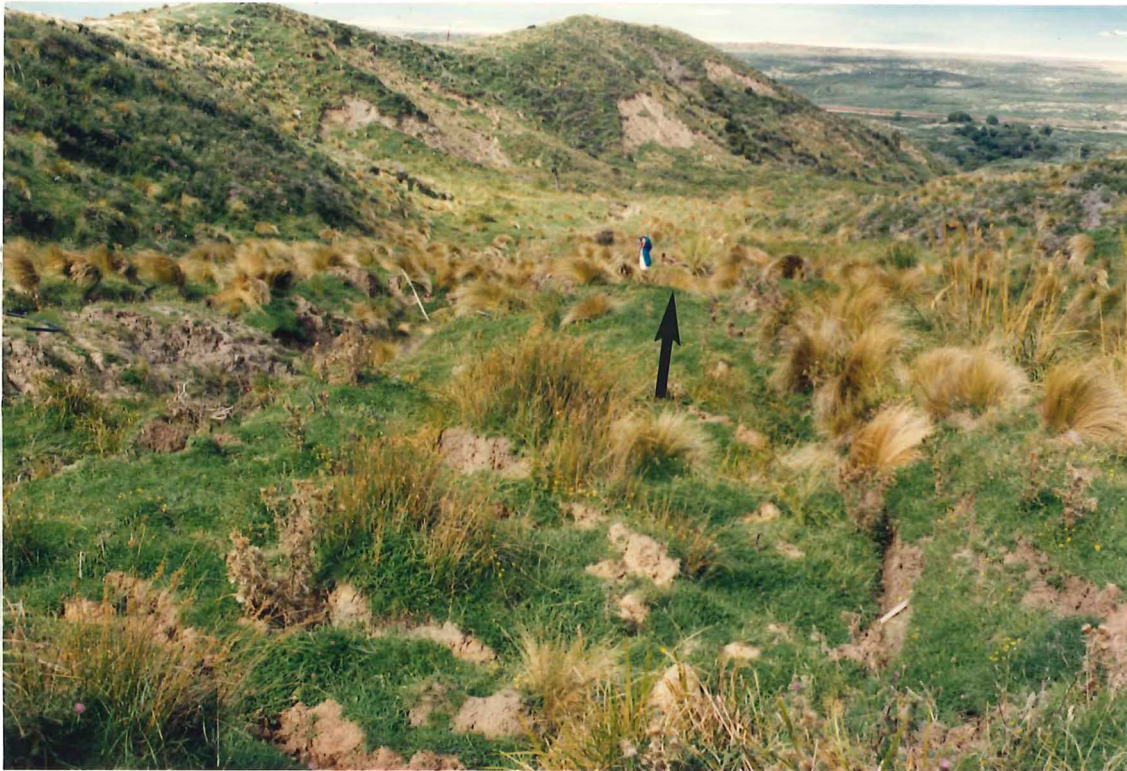
Figure 5.2 Sketch of the area surrounding the zone of local instability shown above. Note that tension cracks are fresh and movement appears to be initiated from gully erosion removing lateral support from the flow body. Arrows denote direction of flow movement.

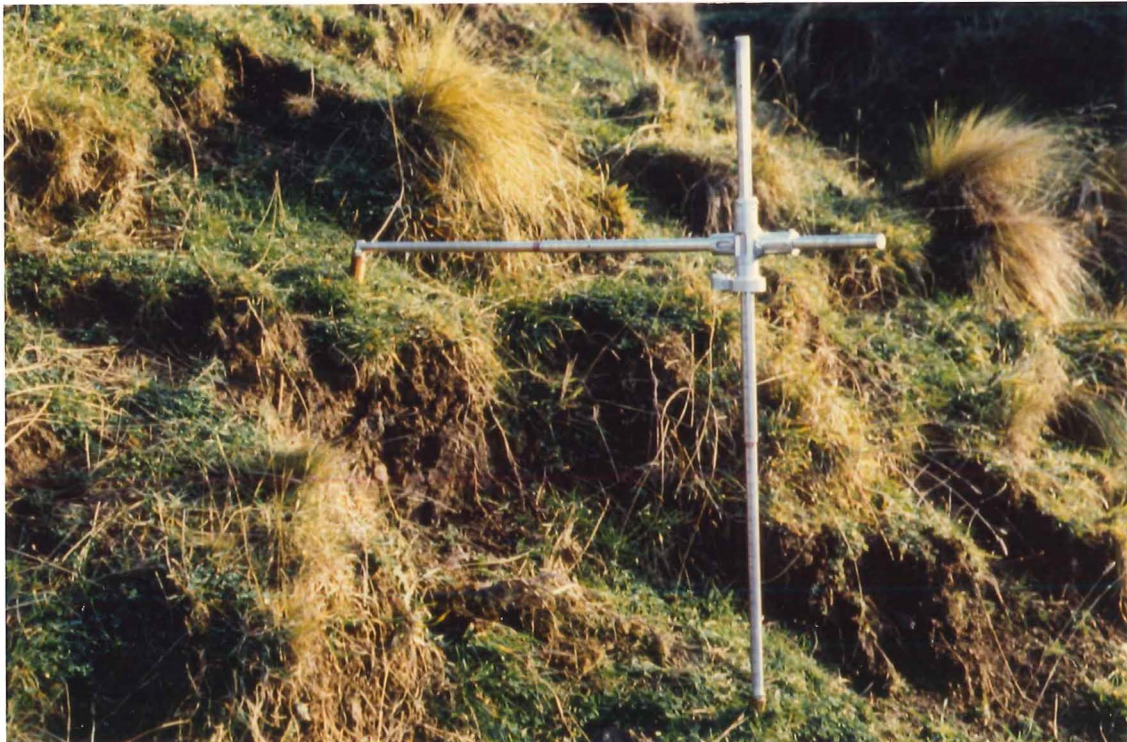
Figure 5.4 Crack width monitor used to measure movement between tension cracks and scarps.

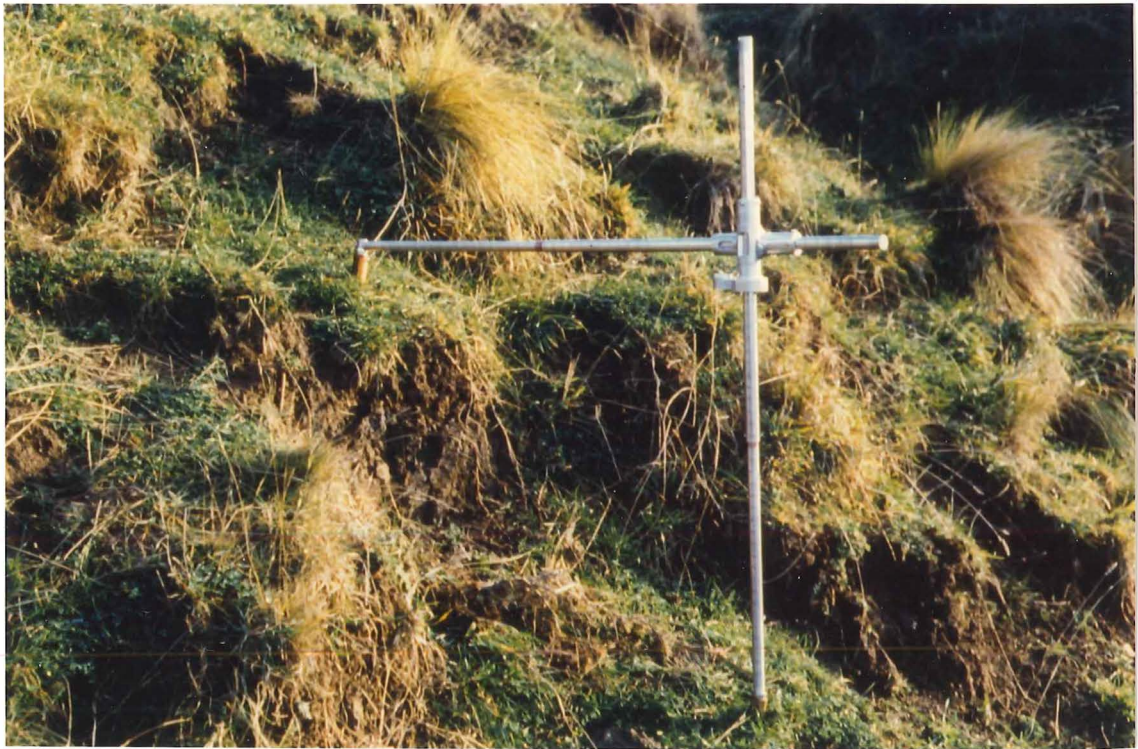
Photo A9.2 Crack width monitor designed and built at the University of Canterbury
